CheckGaadi.com Inspection Report

Order# [CG-BLR-XXXXX]

Inspection Date— 14-Apr-2015

Registration#	KA 01 AB XXXX	Fuel	Diesel
Vehicle Make	Volkswagen	Model	Vento
Manufacture Year	2011	KM Reading	20,021
Chassis Number	XVRT14699BZ014650	Engine Number	GKJKLU172621
Test Drive Taken	Yes	No. of Owners	2

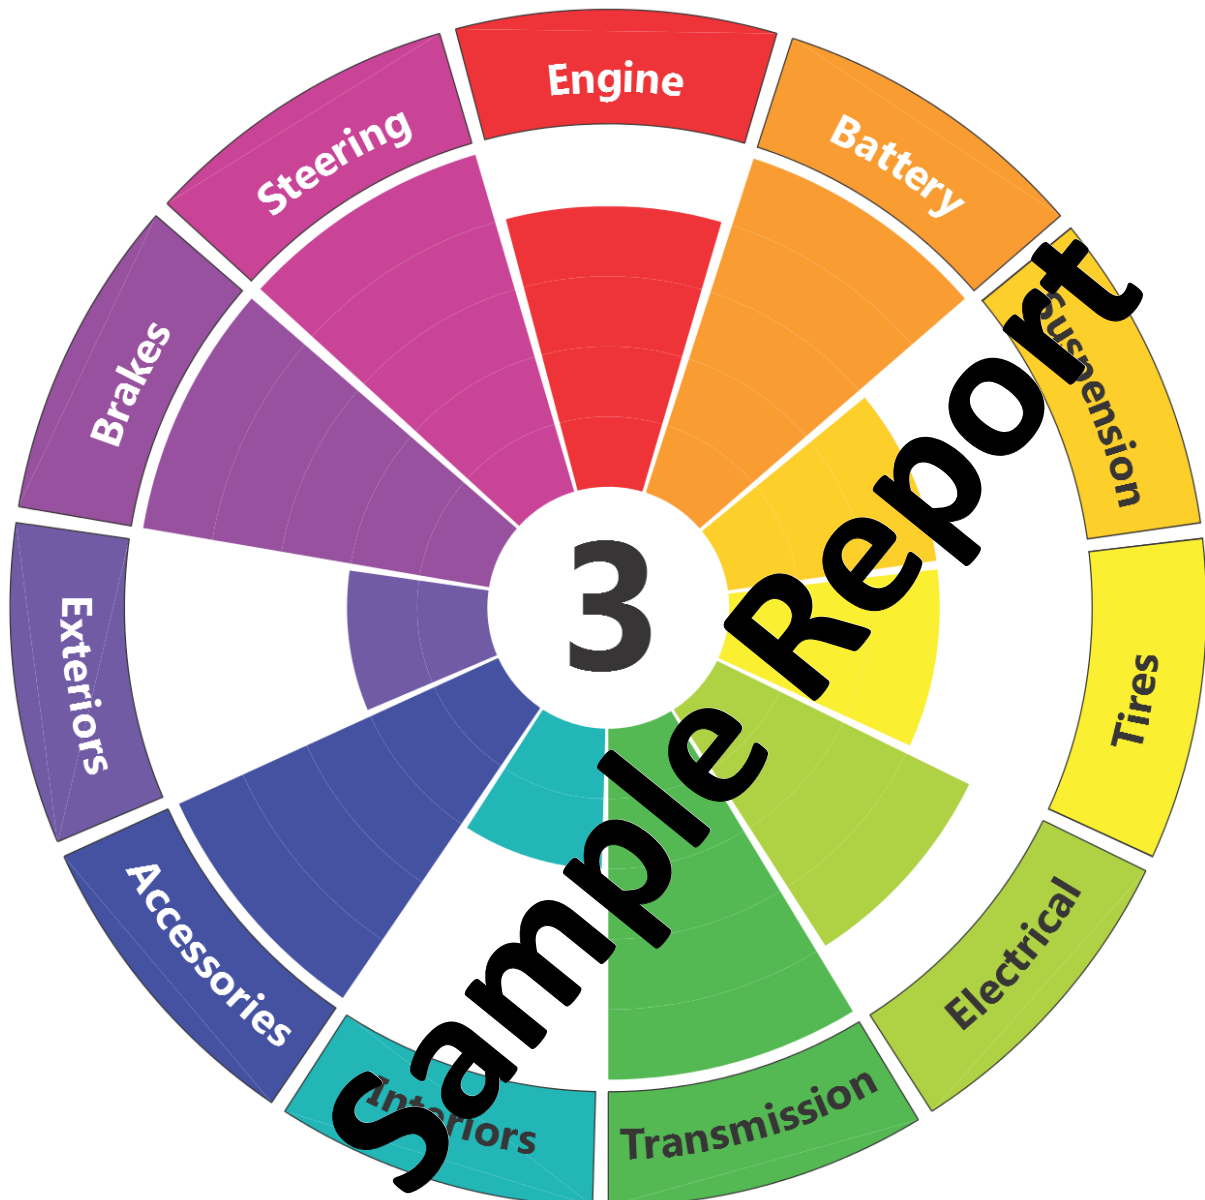
Quality Wheel

Engine		Good	
	Battery		Very Good	
	Suspension		Average	
	Tires		Average	
	Electrical		Good	
	Transmission		Very Good	
	Interiors		Poor	
	Exteriors		Poor	
	Accessories		Very Good	
	Brakes		Very Good	
	Steering		Very Good

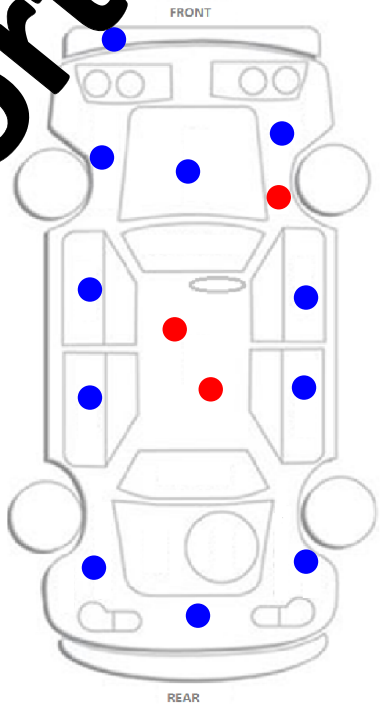
● Dent ● Scratch ● Rust
