CheckGaadi.com Inspection Report

Inspection Date— 14-Apr-2015

Registration#	KA 01 AB XXXX	Fuel	Diesel
Vehicle Make	Volkswagen	Model	Vento
Manufacture Year	2011	KM Reading	20,021
Chassis Number	XVRT14699BZ014650	Engine Number	GKJKLU172621
Test Drive Taken	Yes	No. of Owners	2

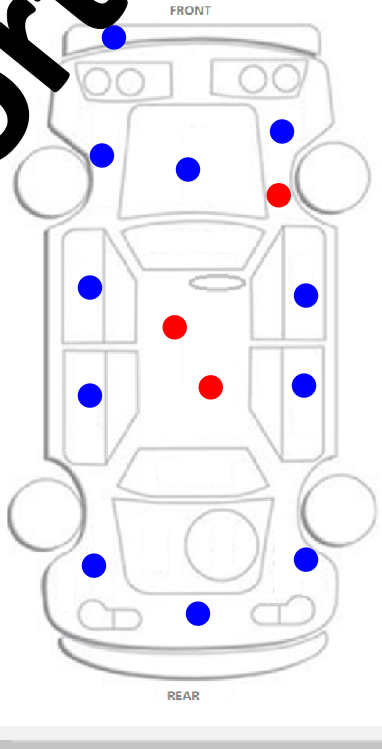
● Dent ● Scratch ● Rust
